GEOTECHNICAL INVESTIGATION

Site:	[REDACTED]
Title:	PHASE II GEOTECHNICAL INVESTIGATION
Project:	DEMOLITION OF COMMERCIAL BUILDINGS AND ERECTION OF TWO DWELLINGS
Client:	[REDACTED]
Contact:	[REDACTED]
Date:	25 <sup>TH</sup> JANUARY 2021
Reference:	[REDACTED]
Version:	V1.0
Prepared by:

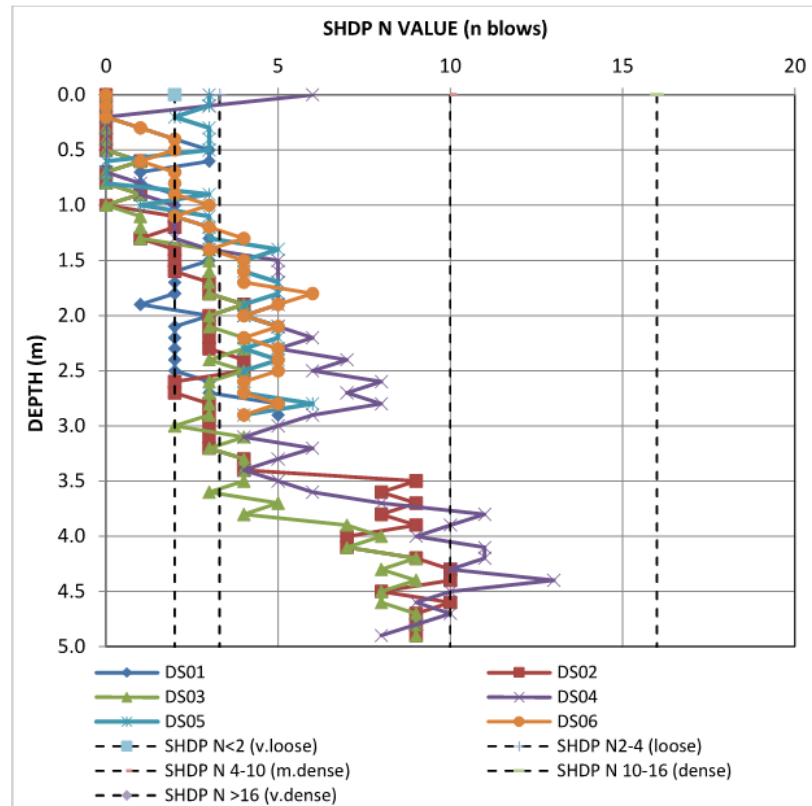
9.1 Dynamic probing (SHDP)

A super heavy dynamic probe (SHDP) was undertaken at all positions. The test is used as a measure of the relative density of granular soils (as defined in BS5930:1999). The test provides limited data in cohesive soils but may be used to illustrate changes in consistency with depth. A typical range of results is summarised below.

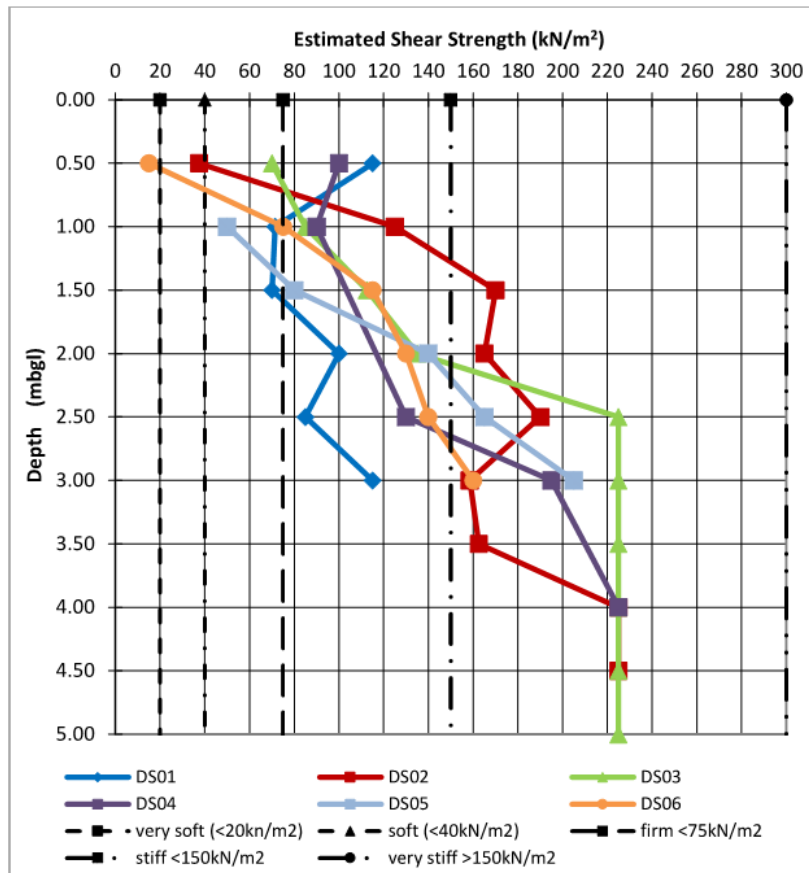
9.3 Penetrometers

Hand penetrometer tests were performed on samples of cohesive materials recovered within the boreholes. The test is used to approximate undrained shear strength and in turn has been used to give an indication of consistency as defined in BS5930. The results are summarised below.

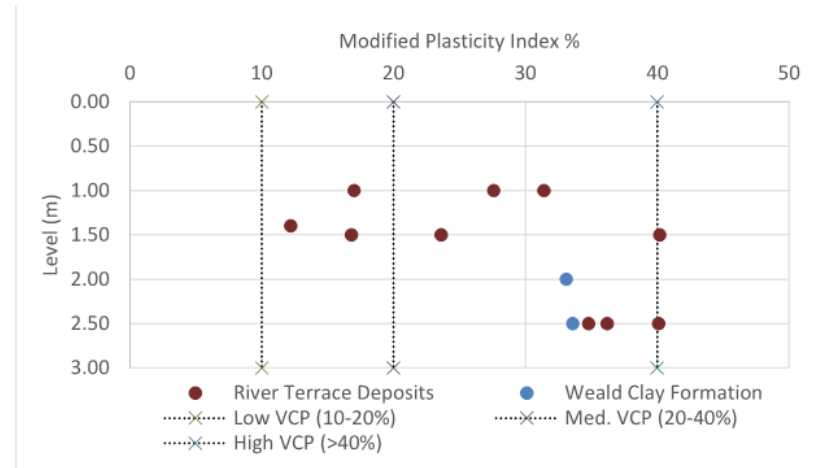
A modified plasticity index (PI') was calculated following the NHBC methodology, to account for any non-shrinkable percentage not passing the 425µm sieve:

Strata	No. of tests	Modified Plasticity Index %		
		Minimum	Maximum	Average
River Terrace Deposits	10	12.2	40.2	28.0
Weald Clay Formation	2	33.1	33.6	33.4

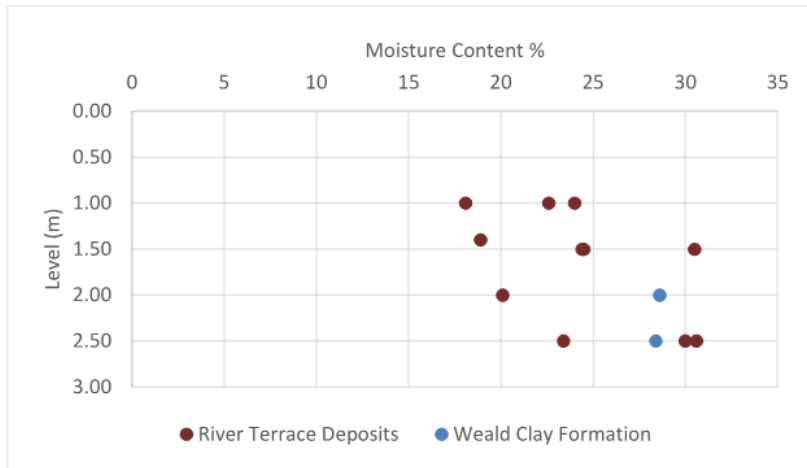
Water content determinations (formerly known as *moisture content*) were undertaken in combination with various classification tests, and the results are summarised on the following page.

Strata	No. of tests	Moisture content %		
		Minimum	Maximum	Average
River Terrace Deposits	11	18.1	30.6	24.3
Weald Clay Formation	2	28.4	28.6	28.5
